Performance of Aluminum Riveted Culvert in California

T.J. Summerson and R.J. Hogan

Center for Technology  
Kaiser Aluminum & Chemical Corporation  
Pleasanton, CA 94566

ZCFT-79-39-TJS/RJH  
NOVEMBER 1, 1979

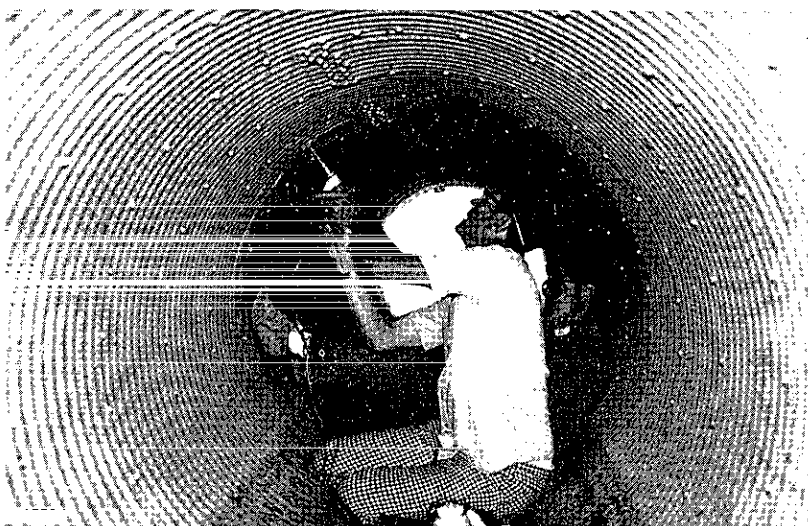
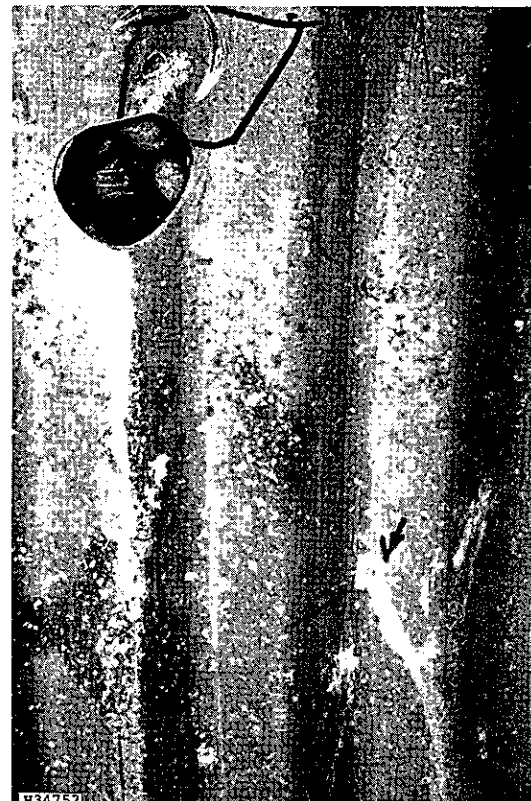
Figure 2

At Site 71-021, on Florin Road in Sacramento County, a few pinhole perforations were found in only one of the three pipes at this location. Ultrasonic thickness measurement survey showed the perforations were contained in a relatively small area in one or two 2-foot lengths of the one pipe. Nothing unusual was detected from the chemical analyses of the soil (71-021C in Tables II and III) taken from behind the metal sample with a perforation. As shown in Figure 2, the overall appearance and structural soundness of the culvert has been unaffected.

Site #71-021 - SACRAMENTO COUNTY - FLORIN RD.

Three 48-inch diameter, 12 gage Alclad 3004 pipes were installed in 1963. In 1978 (15 years), a few pinhole perforations were found in one two-foot section of one of the three pipes. The photo on the right shows where one pinhole perforation is marked by the black square and another pinhole is marked by black arrows. Ultrasonic thickness gage was used to determine extent of corrosion on soil side around these pinhole perforations. Full thickness was measured within 0.25 inches of each pinhole. The overall good appearance and condition of the pipe is indicated in the lower left photo, showing patch placement over the metal samples taken (see F21, 22 and 23).

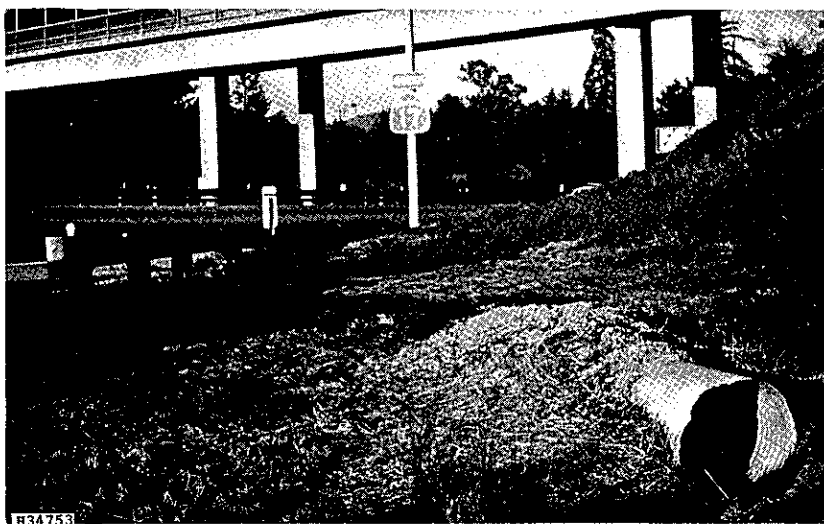
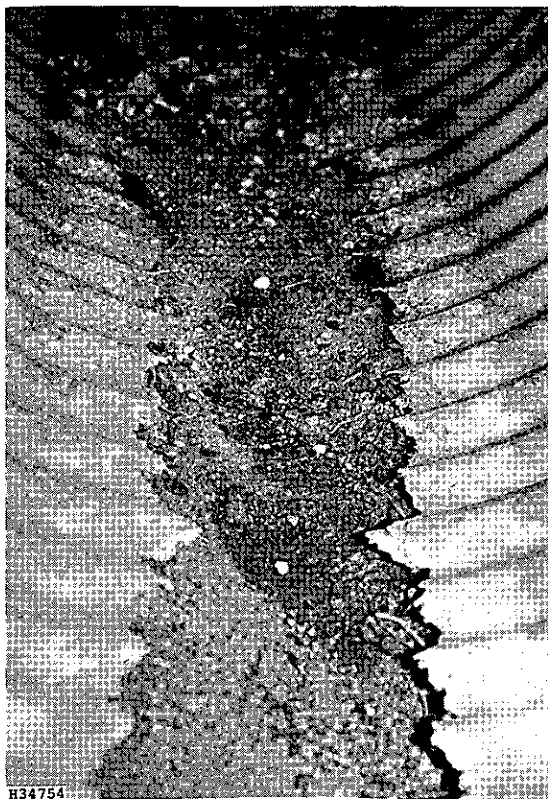
in less than one year. As Figure 3 shows, the pipe is still intact after 16 years, although the invert is completely corroded away. The explanation for corrosion in this instance appears to be related to the low pH (3.7-3.9) reported in 1978, as well as in the original 1965 report.

Site #78-28 - SANTA CRUZ - SCOTT'S CROSSING  
(IV-SCr-5-A)

In 1978, pH and minimum resistivity were measured as 3.8 and 5,000 ohm-cm. In 1964, they were reported as 3.7 and 330 ohm-cm.

In 1964, the invert was reported to have corroded through (perforated) in 0.83 years. (See Fig. 13 of Nordlin & Stratfull report.) In 1978, the invert (above) was found to be completely corroded through as the result of water side corrosion. However, soil side corrosion is still confined to the cladding thickness. See Figures F54 and F55 in this report.

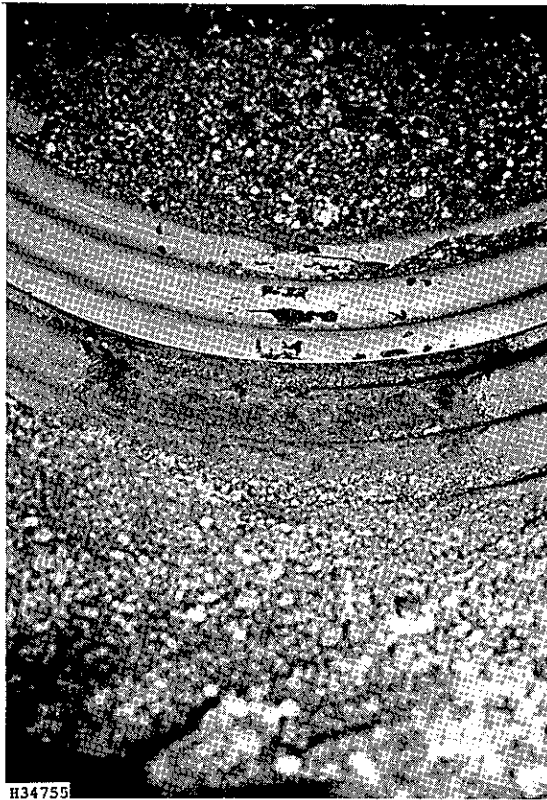
Site #67-126 - CALAVERAS COUNTY - HIGHWAY 4, EAST OF CAMP CONNELL

Installed in 1962 - 24 inch diameter, 14 gage pipe

Shown is the invert of aluminum pipe with an extension of galvanized steel pipe in foreground. The aluminum pipe was found to be in excellent condition, invert and soil sides. See Figure F33.

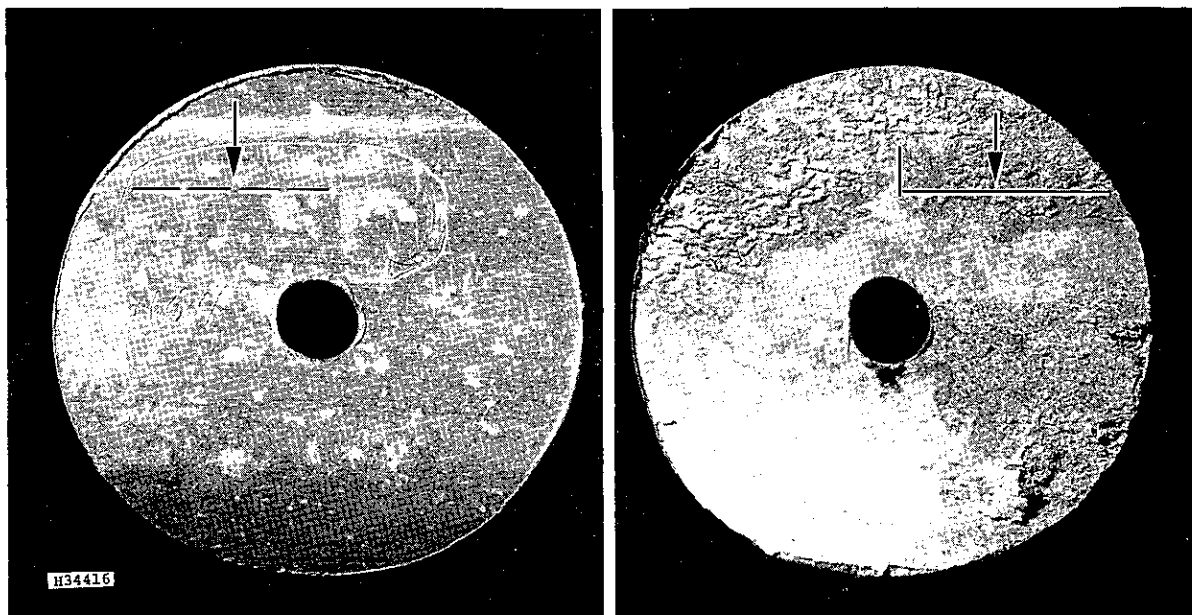
Crown Area

Soil Side: Corrosion of the cladding layer and into the core alloy was measured at 0.094-0.098 inches.

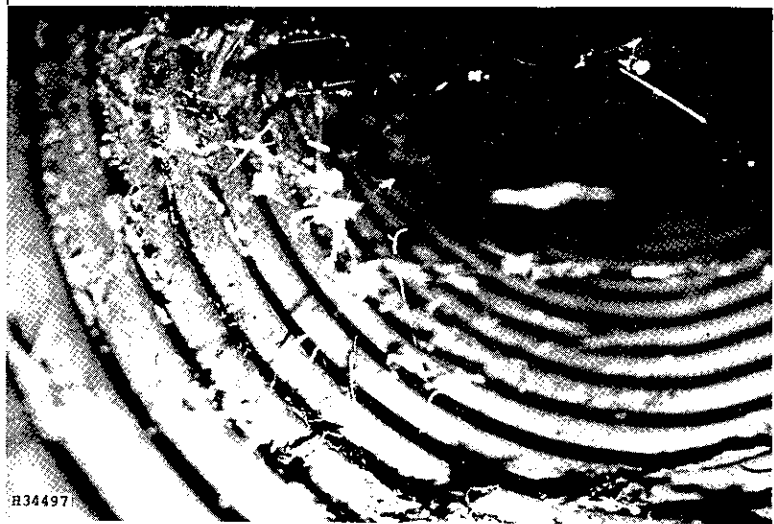
Springline & Invert

Photo and visual inspection show culvert  
was extremely dirty and appears to be in  
excellent condition

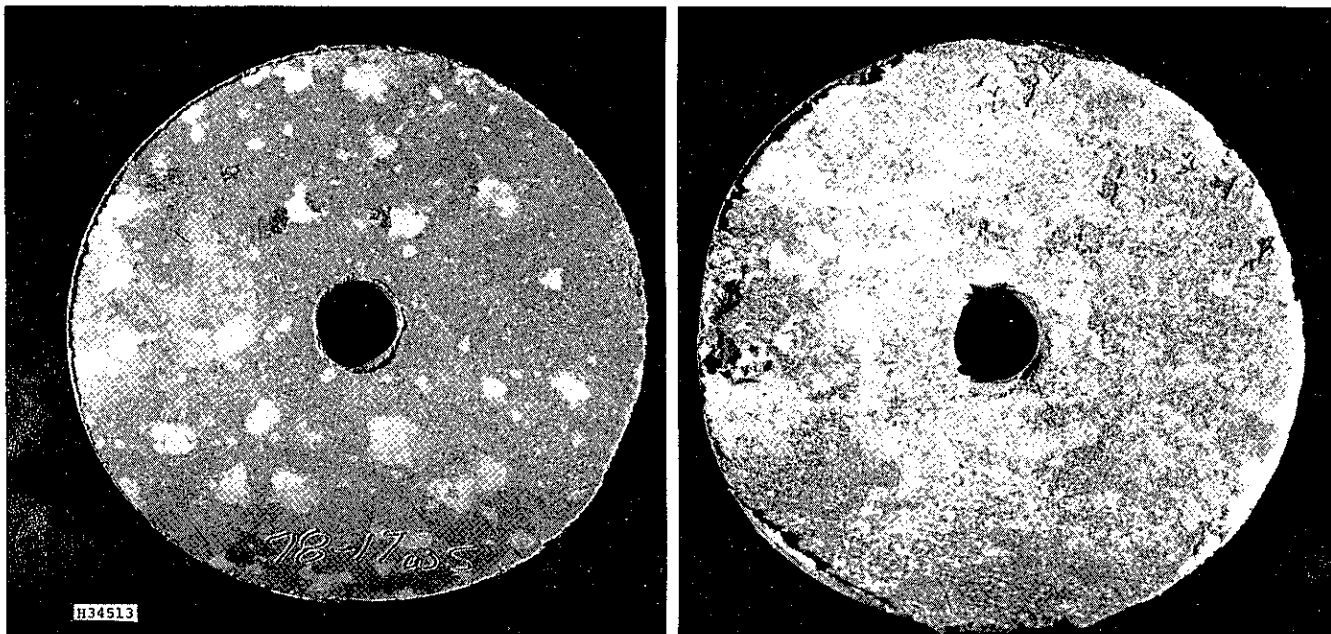
Water Side: Occasional pits in cladding

NOTE: This coupon was taken adjacent to  
(within 1/4 inch) the perforated sample  
on the page to the left.

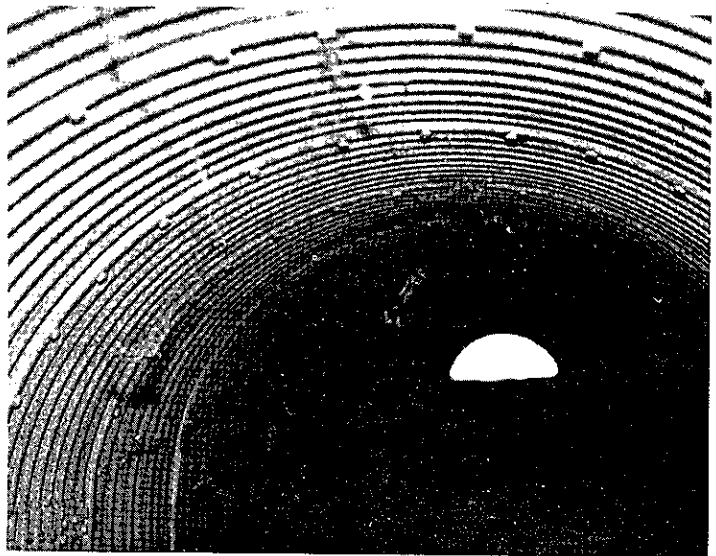
SITE #78-22     Riverside Co., Rancho California, Cabrillo Ave.  
                         at intersection with Vallejo Dr. (Site #48)

Alclad 3004, 2 ea. 48" diam, 8 ga.,  
installed 1968

An inspection was made through both pipes,  
and they appear to be in excellent condition.

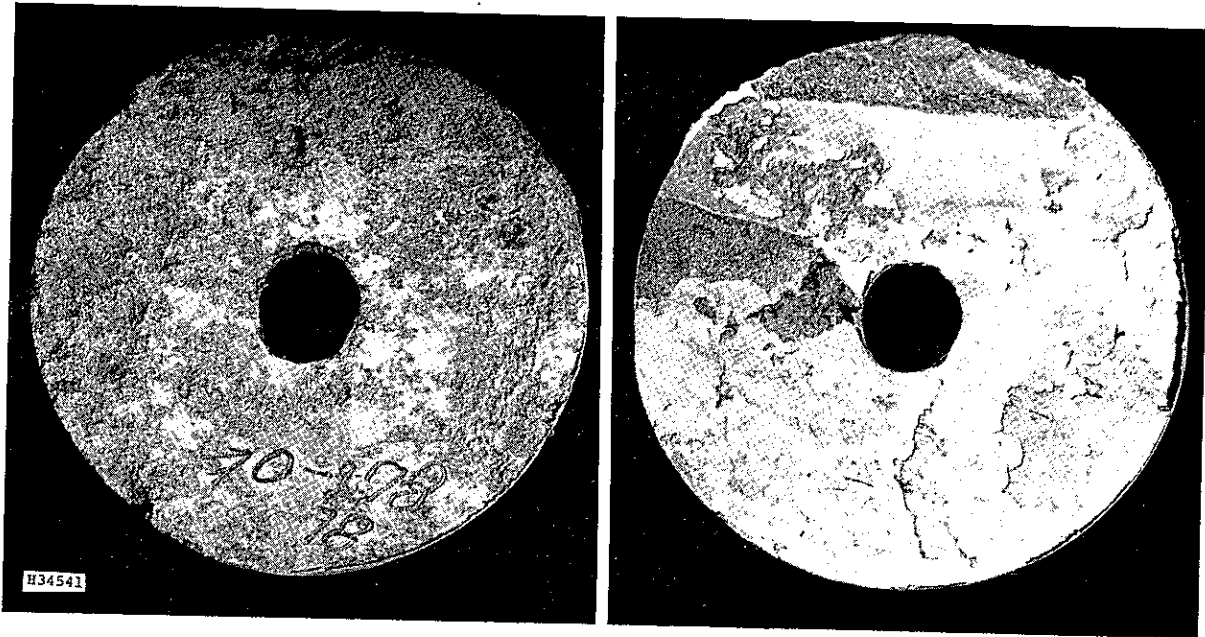
1-Foot From Outlet End

At the Chula Vista location (67-178) there have been no perforations and corrosion is limited to the cladding on the soil side. However, deep pitting (53 mils maximum) was

reported on the water (invert) side. (See F-92.) Although some soil and miscellaneous debris were lying in the invert, there was not enough to analyze and to determine the cause of this water side corrosion.

Water Side: Deep pitting to 0.053-inch.  
(Soil and debris lying in water  
side)
